ICANDY ORANGE SAFETY INITIATIVE

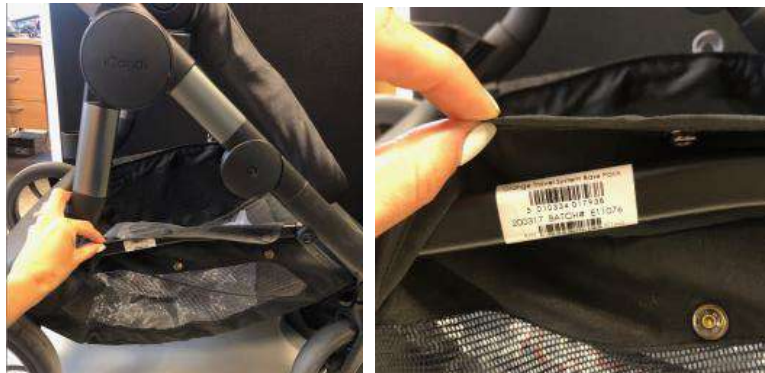
This relates specifically to the following batches: E11076, 11125, 11147, 11159, 11160 of the Orange 2017 pushchair. To check if your iCandy Orange pushchair falls within the identified batches please check the batch number on the chassis, location of the batch label is shown in the images below:

If your iCandy Orange DOES NOT fall within the affected batches, this notice does not affect your pushchair.

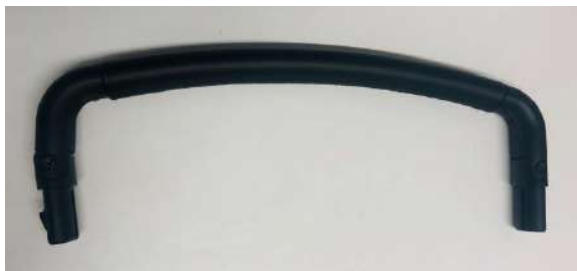
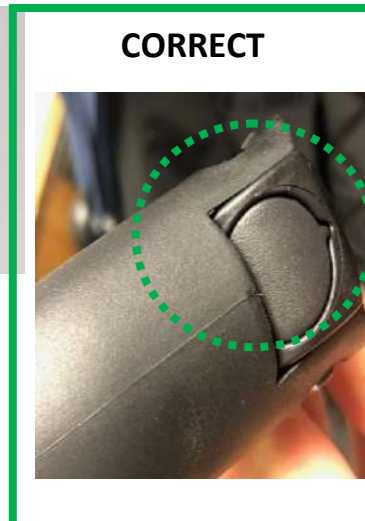
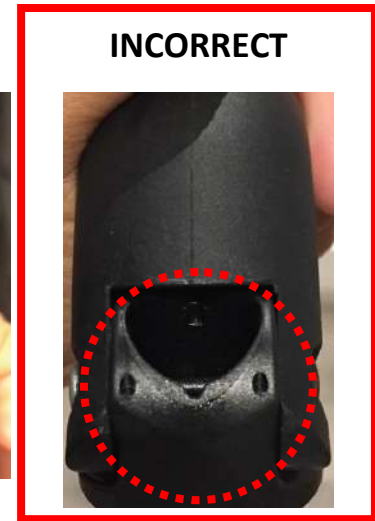
As part of iCandy's ongoing product monitoring programme, it was identified that within certain batches the iCandy Orange bumper bars were missing a plastic cap which results in there being a small hole in the bumper bar, visible at the base of the hinge mechanism. It should be noted that this hole is only accessible when the bumper bar has been removed and levered back on one side.

If your iCandy Orange DOES fall within these affected batches, iCandy would like to take this opportunity to request users to carry out a visible check of their product. This can be done quickly by removing and assessing the bumper bar, see images below for reference.

If both caps are in place, the pushchair is safe to use and no further action required. iCandy would also like to reassure customers that it is not possible for them to become dislodged or detached at any point in the future.

If the plastic cap is missing then a new bumper bar is required, it can be requested by telephoning customer services or going online, details of which can be found below:
